Knysna Fire Report

Investigation Method

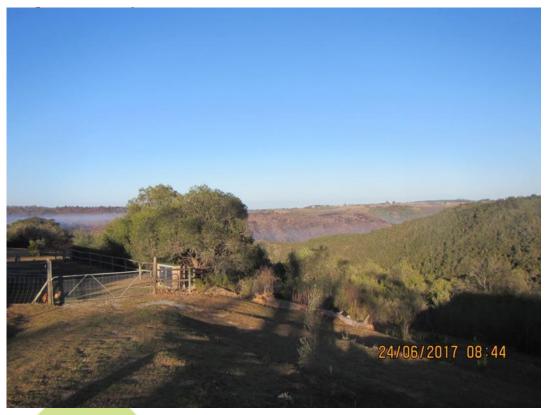
Photo received from resident

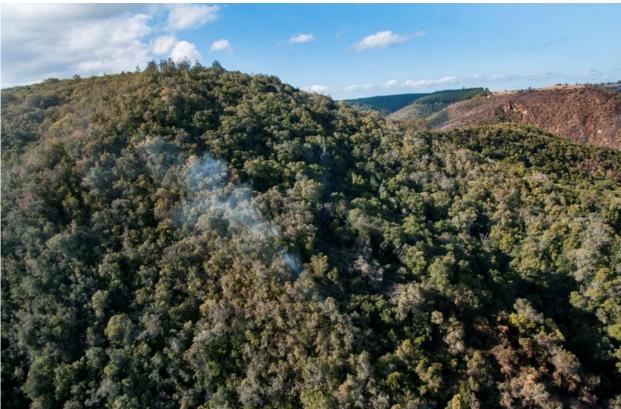
Smoulder photo 12 July

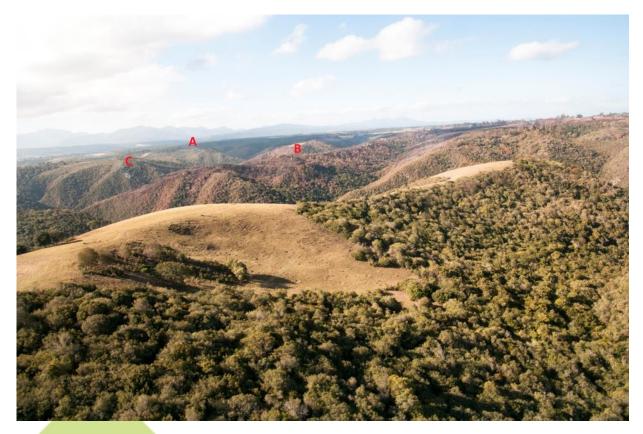
Smoke location

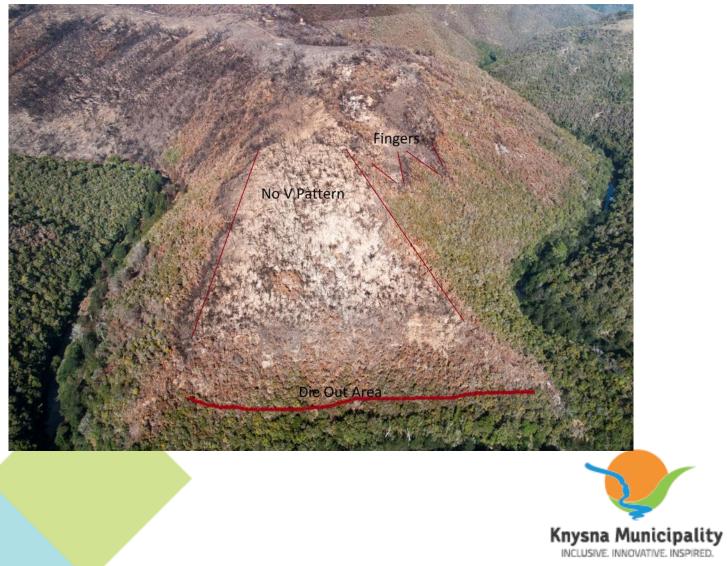
No V Pattern Area

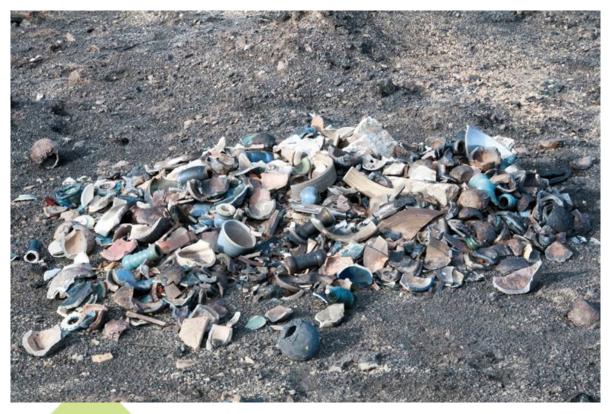
Pottery remains

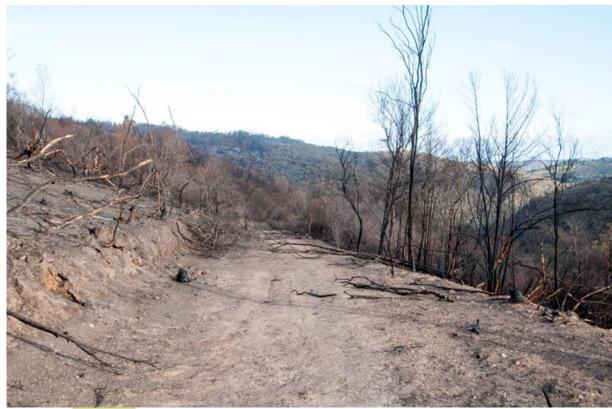
Access Path

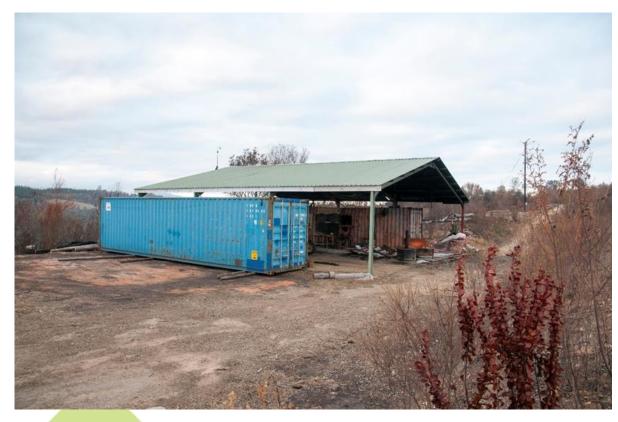
Shed

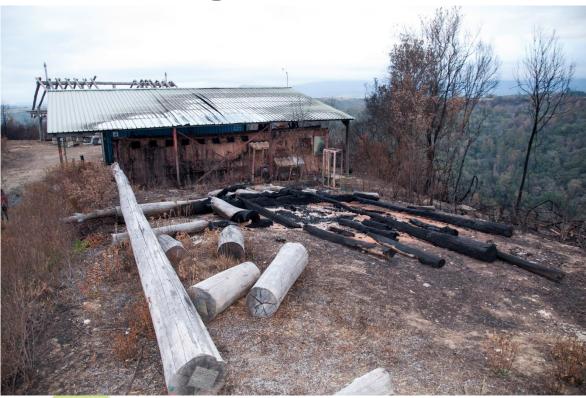
Shed damage from Eastern side

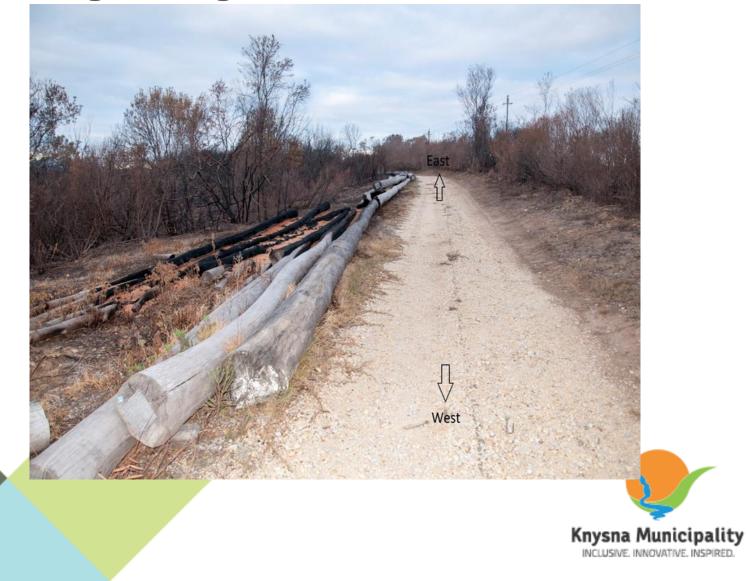
Log damage from Eastern side

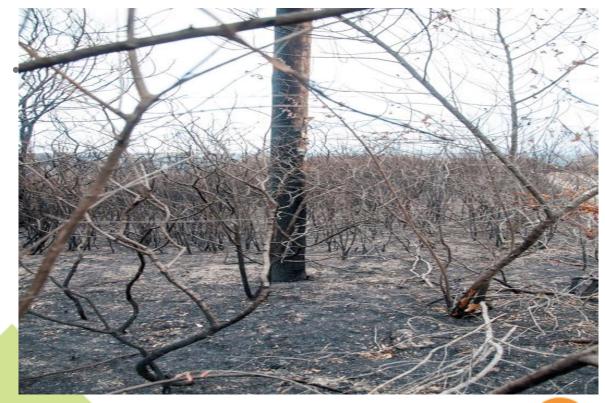
Burn Scar on poles from Eastern side

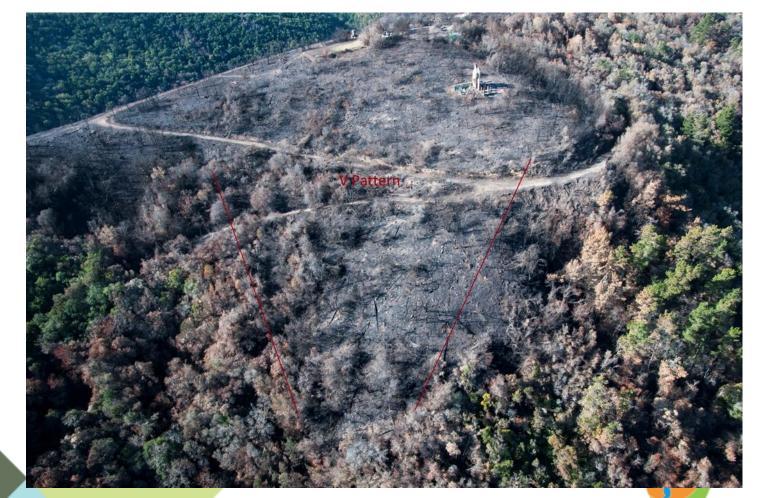
V Pattern Burn Scar

- V Shape area
- First ignition point in clearing

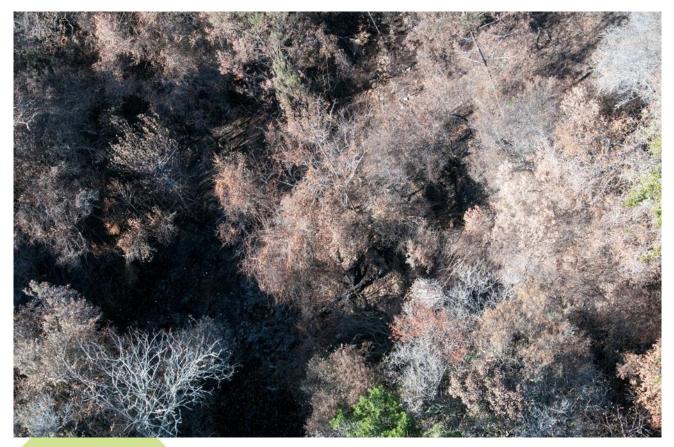
Clearing at bottom of V

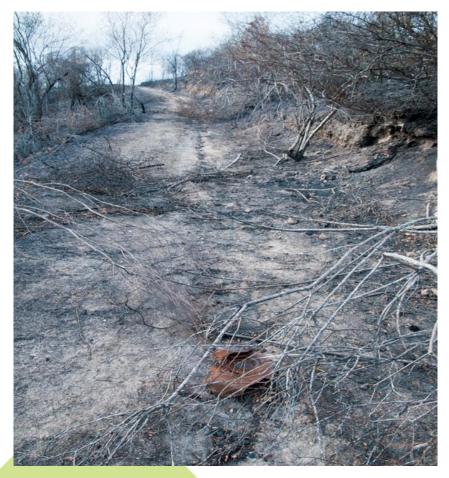
Access to V Section

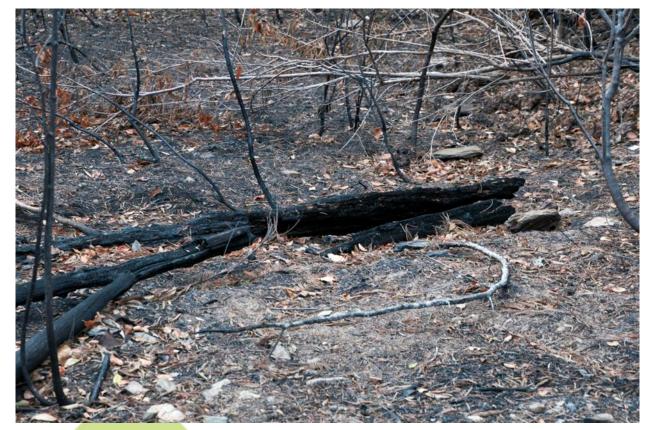
Heavy fuel in clearing

Probable Cause - Pine cones and stacked heavy fuels ignited

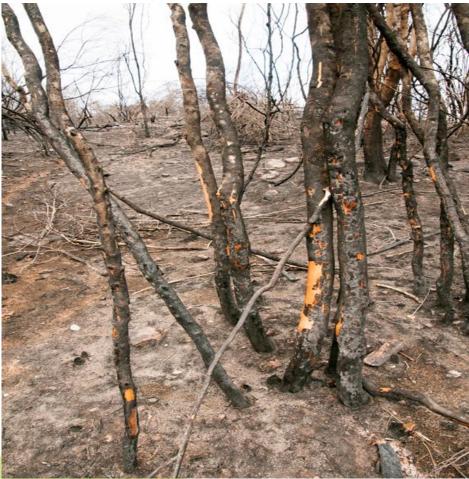
Charring uphill

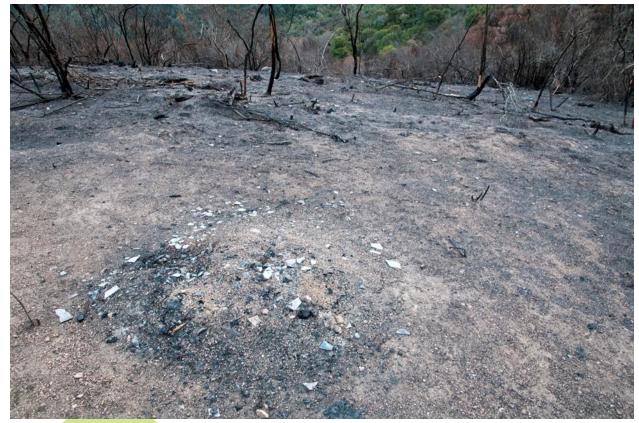
Previous fires in area

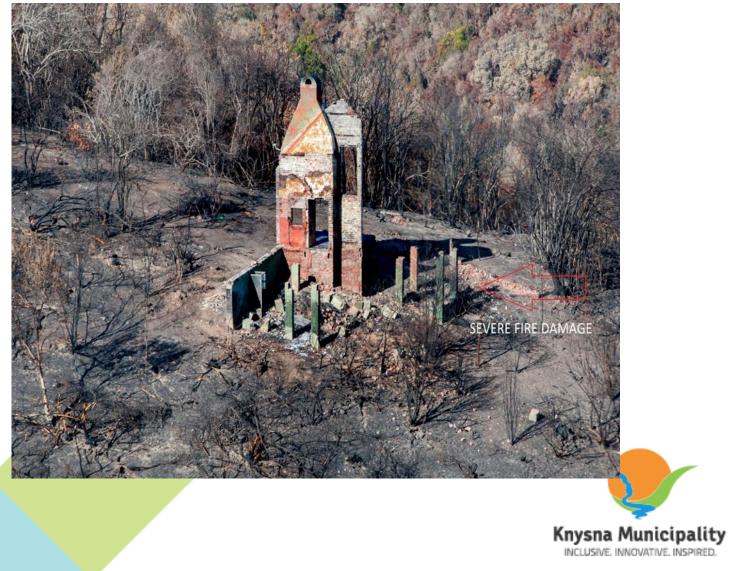
Structure in V Path

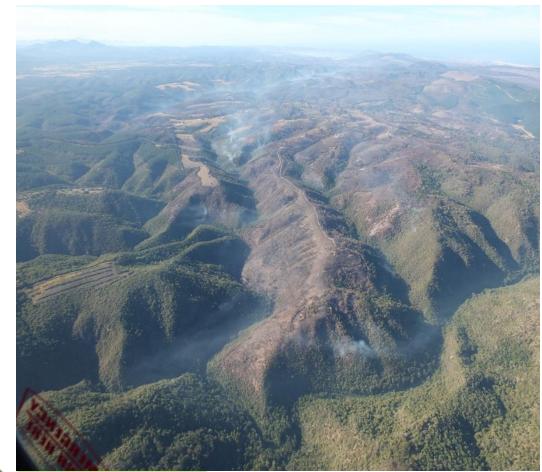
Burnt scar
