Knysna Fire Report

Investigation Method

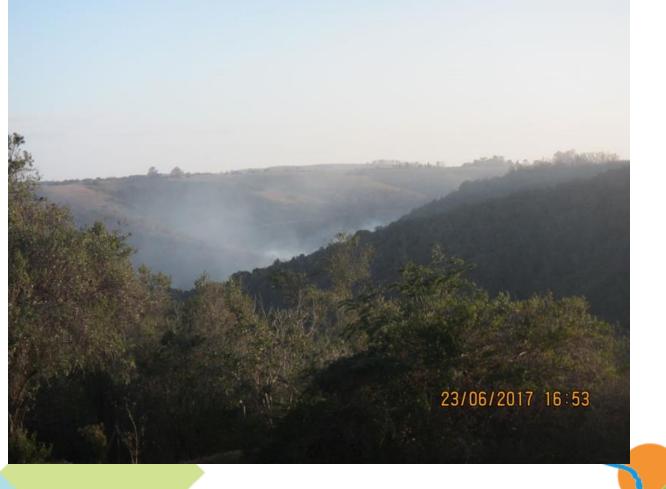
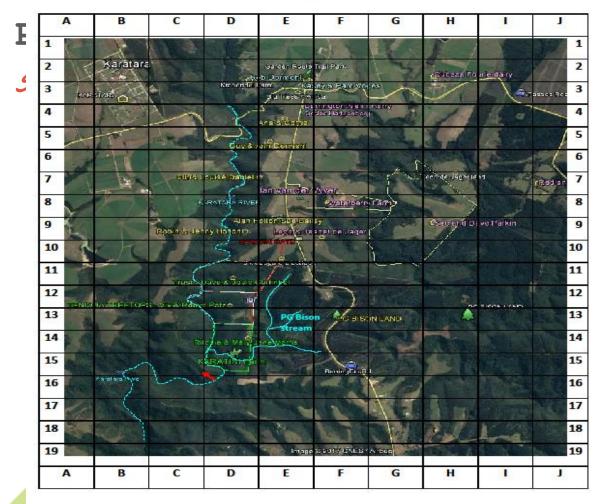
Another email from resident 23 June 2017

BARRINGTON – ELANDSKRAAL – ROOIKRAAL – ROODEKRAAL AREA GRID MAP. IDENTIFY A GRID, EG TENIQUA TREETOPS = D12 OR D13, Suggest you print a copy and keep with you.
